## Tests of fire suppression effectiveness of damaged water mist systems

DRDC-RDDC-2014-C70  
May 2014

### SP Technical Research Institute of Sweden

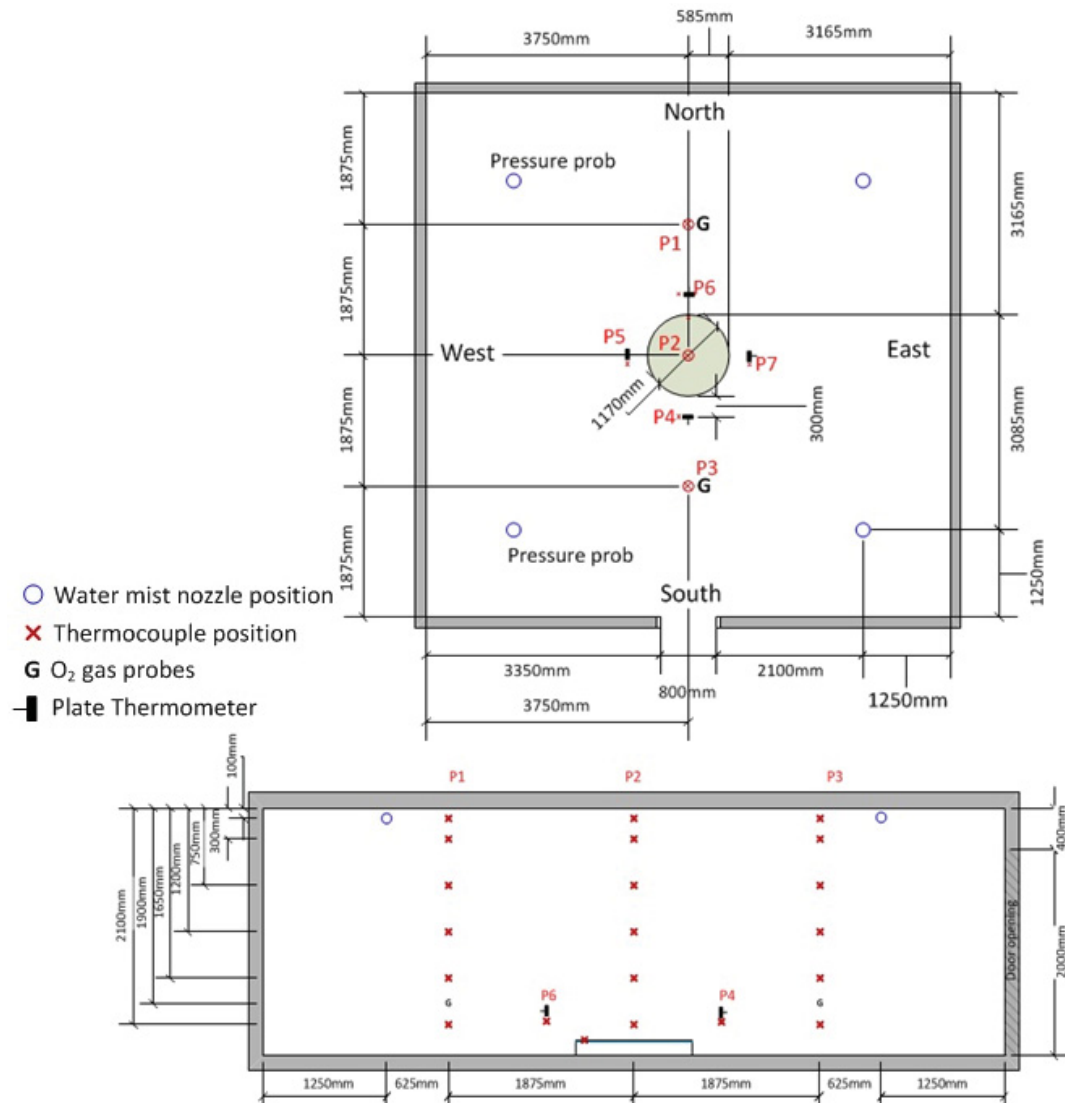
Figure 1. Schematic of test compartment used for the damaged water mist tests.

Figure 1 shows an overview of set up of the test compartment for the damaged water mist system tests and Figure 2 shows an overview of the set up for the torpedo dummy tests.

When equipment and measuring devices are described with compass directions, south is towards the door, as shown in Figure 1.

The diesel pool fire was allowed to burn for 30 seconds prior to the activation of the system. Average gas temperatures in the compartment were calculated as an average of the temperatures of thermocouples in the thermocouple trees at P1 and P3 in Figure 1. The results are presented in Figure 5, Figure 9 and Figure 13.

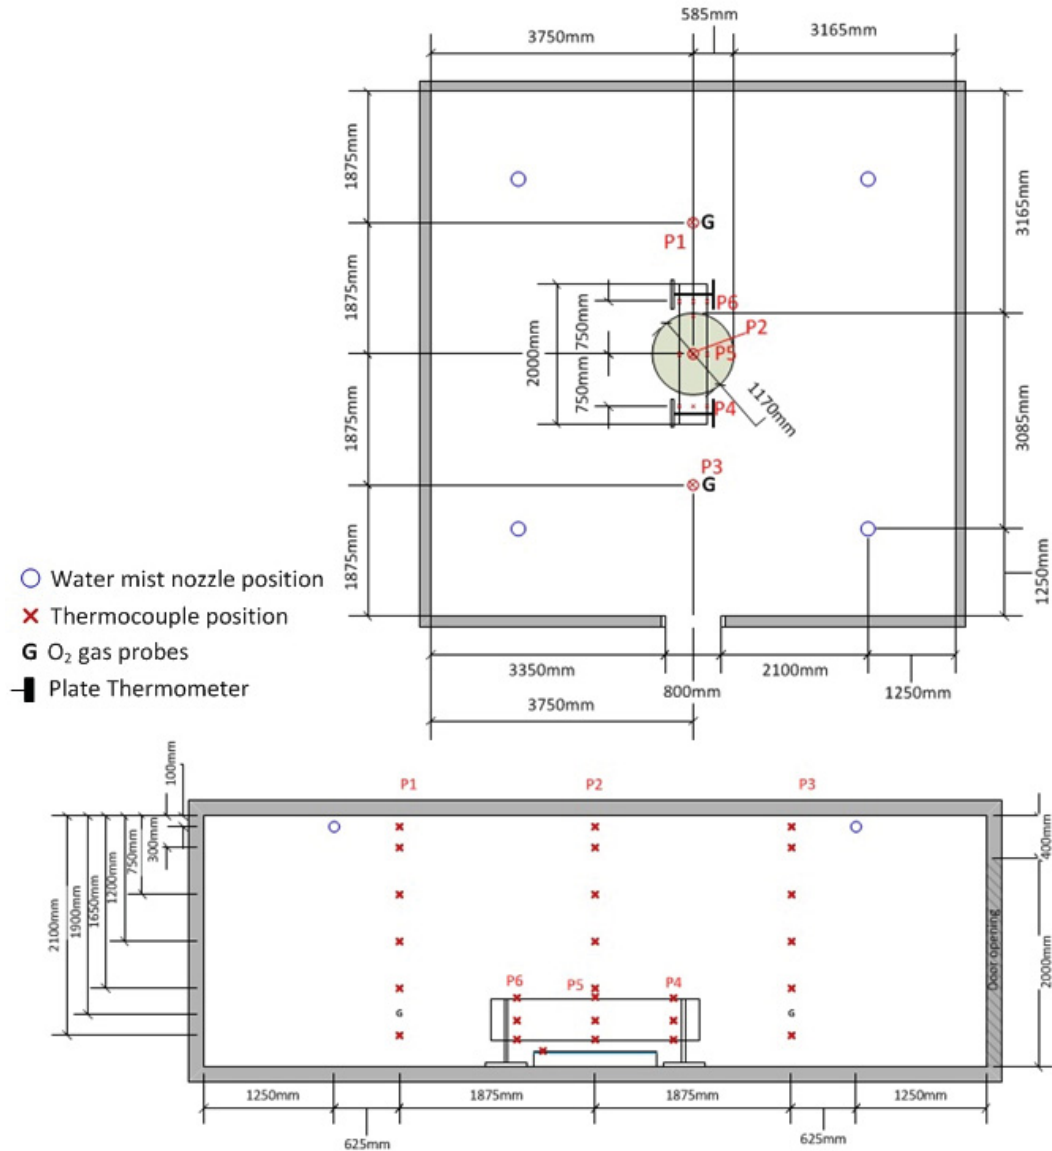
Figure 2. Schematic of test compartment used for the torpedo dummy tests.

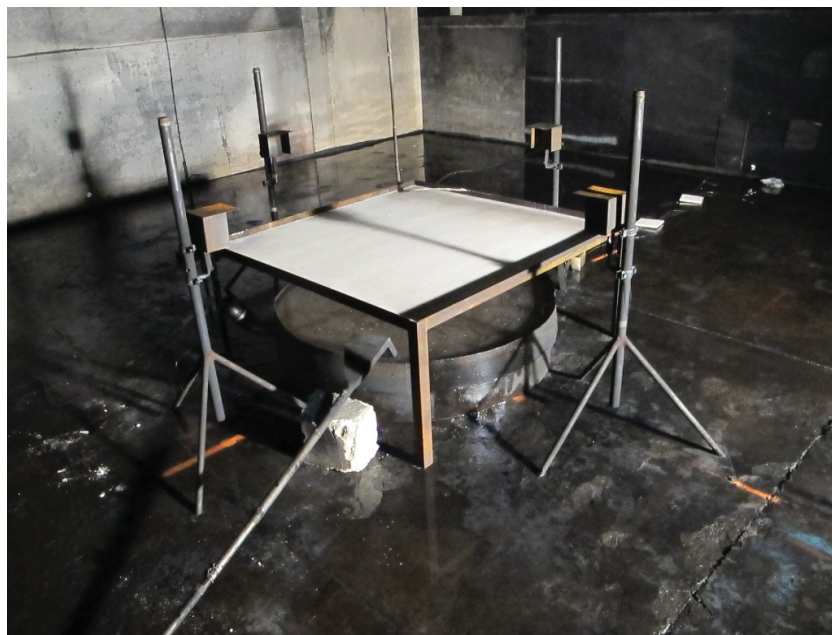
**Figure 3** Experimental set-up for the 100% obstructed fuel pan fire.

The fires were run without obstruction, with 100% obstruction, and with 50% obstruction. To achieve 100 % obstruction of the circular fuel pan, a Promatect sheet was placed 250 mm above the fuel surface as shown in Figure 3.

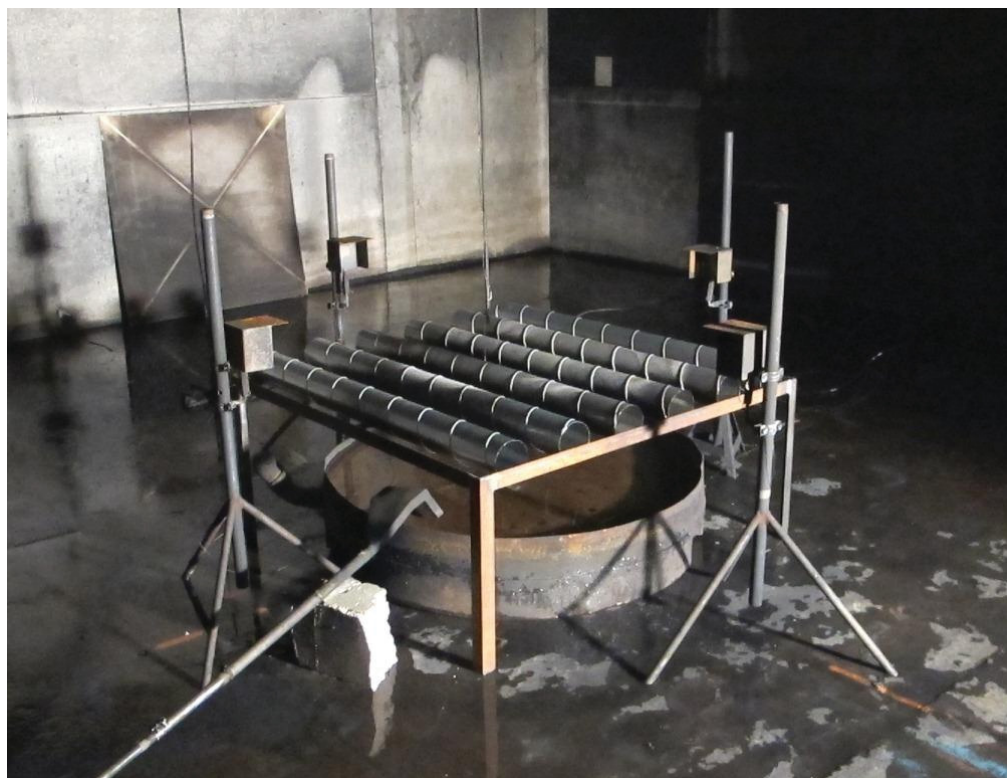
**Figure 4** Experimental set-up for the 50% obstructed fuel pan fire.

To achieve a 50 % obstruction of the circular fuel pan, six spiro pipes (100 mm outside diameter) were placed 250 mm above the fuel surface as shown in Figure 4.

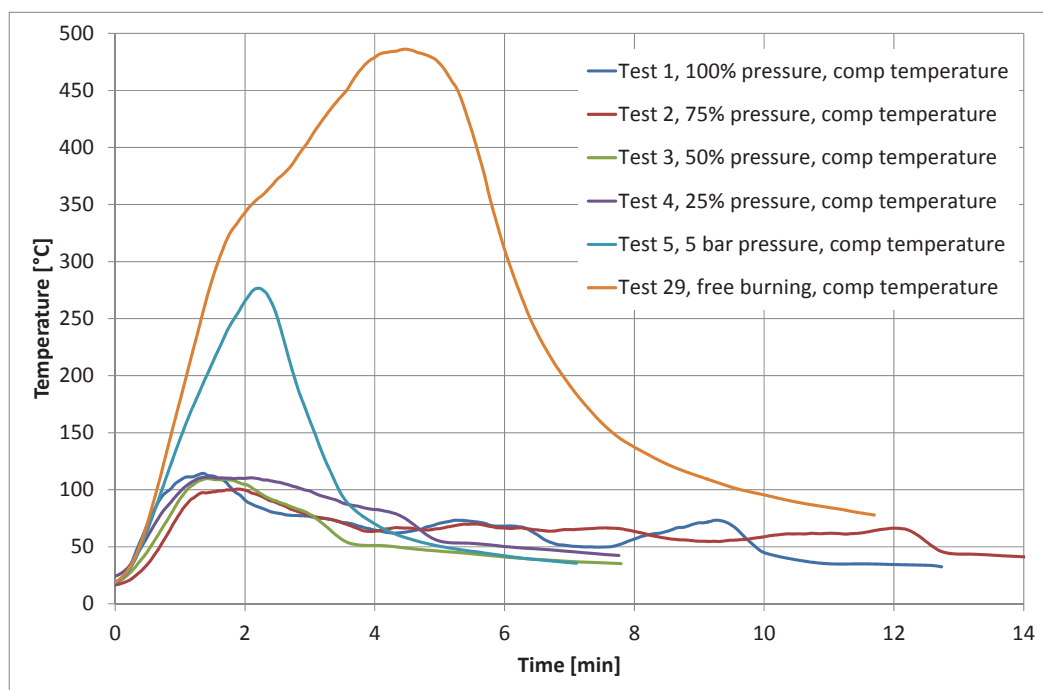
Figure 5 – Average compartment temperatures versus time for non-obstructed pool fire water mist suppression tests.

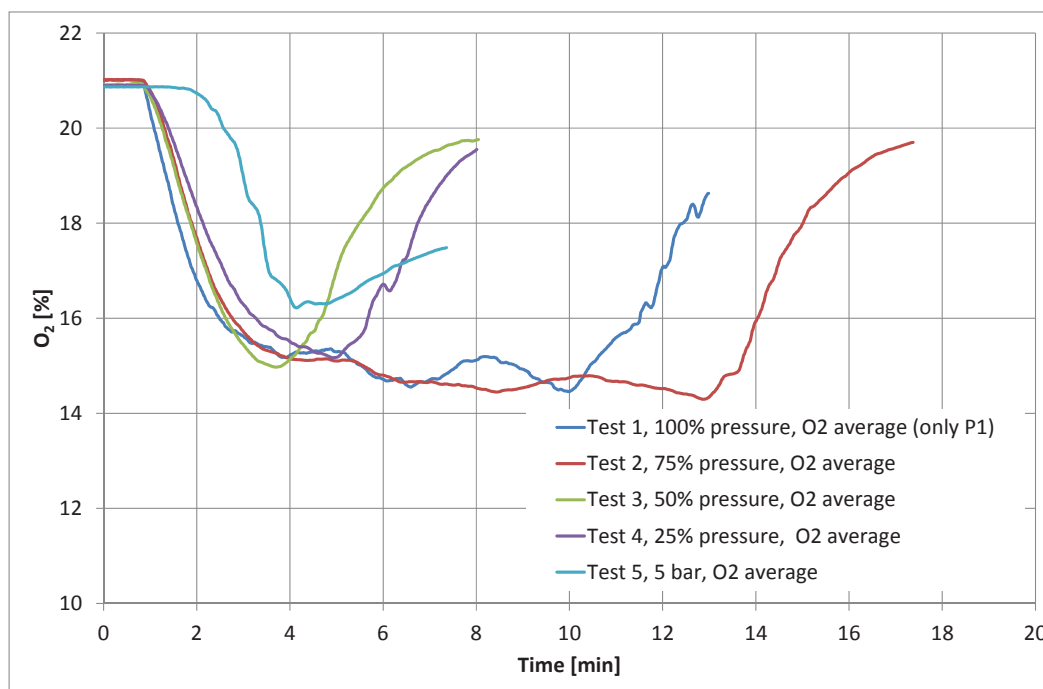
Figure 6 – Average oxygen concentrations versus time for non-obstructed tests.

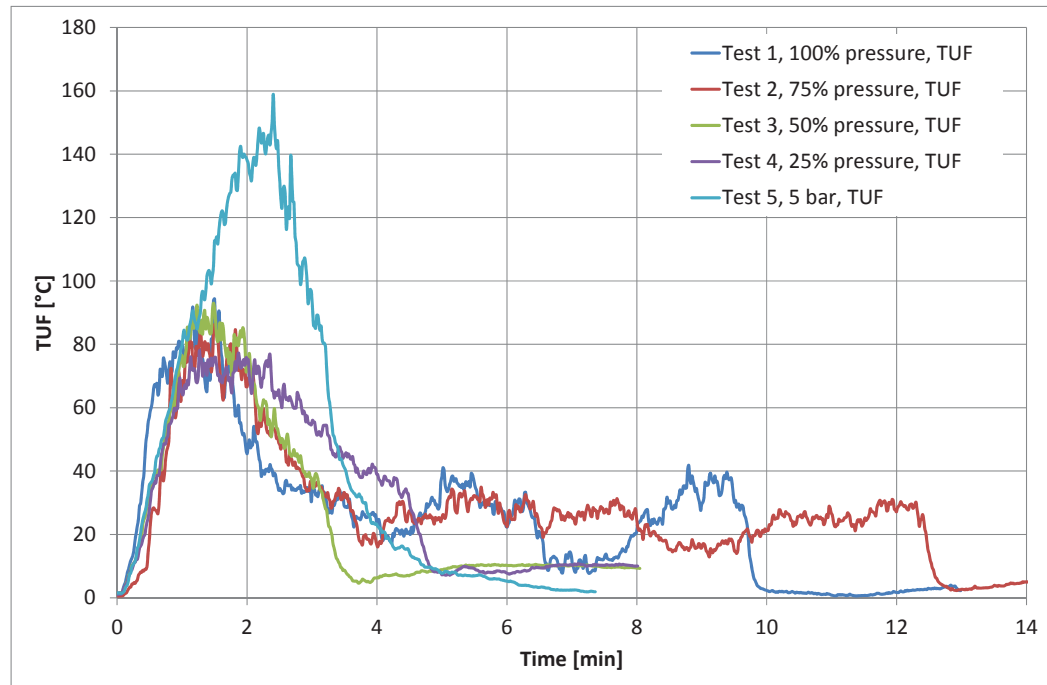
Figure 7 – Temperature Uniformity Factors versus time for non-obstructed tests.

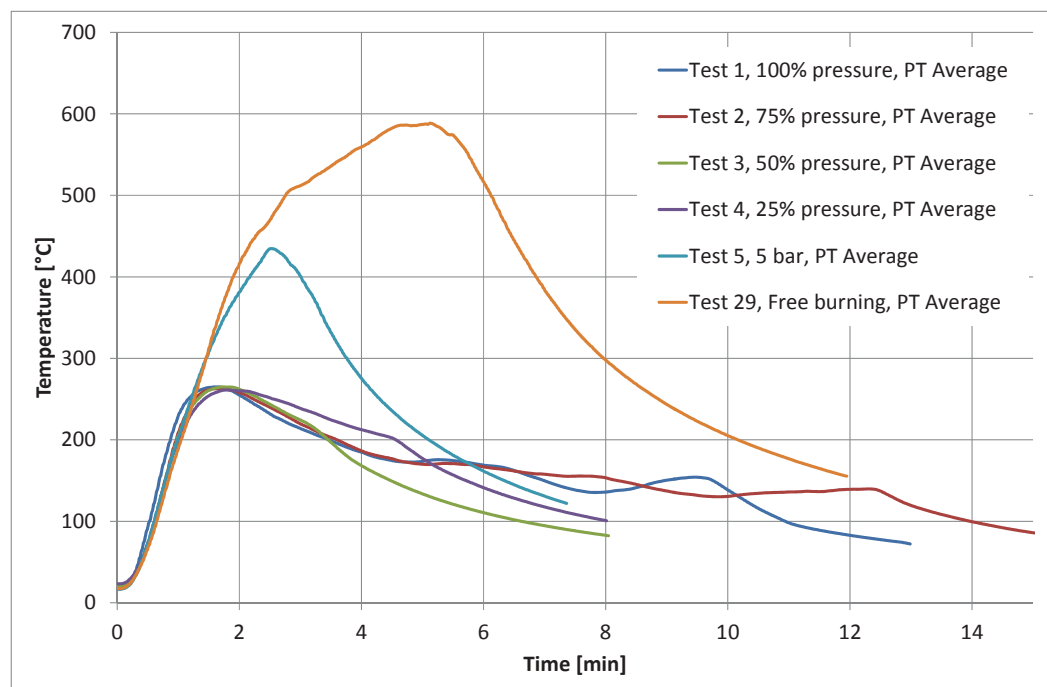
Figure 8 – Average PT (plate thermometer) temperatures versus time for non-obstructed tests.

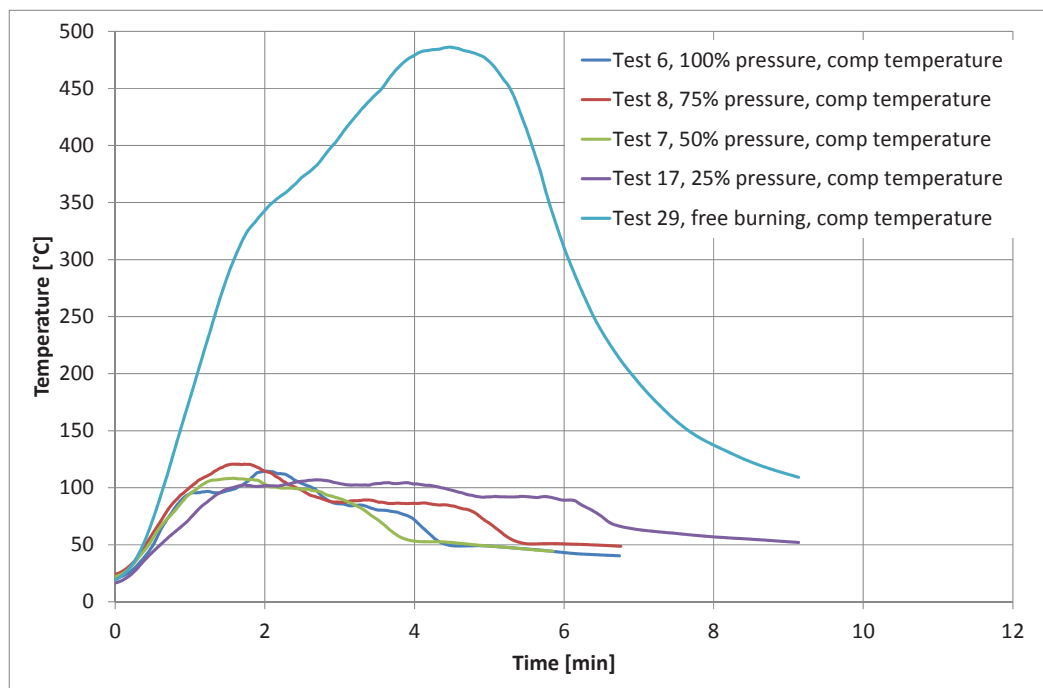
Figure 9 – Average compartment temperatures versus time for 100% obstructed fire tests.

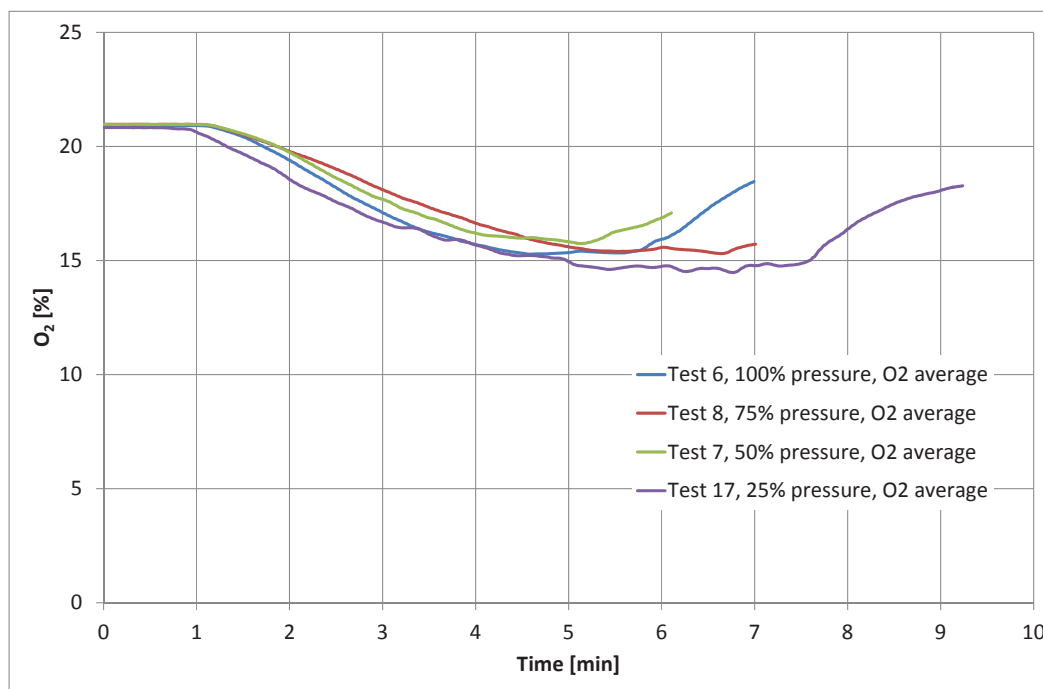
Figure 10 – Average oxygen concentrations versus time for 100% obstructed fire tests.

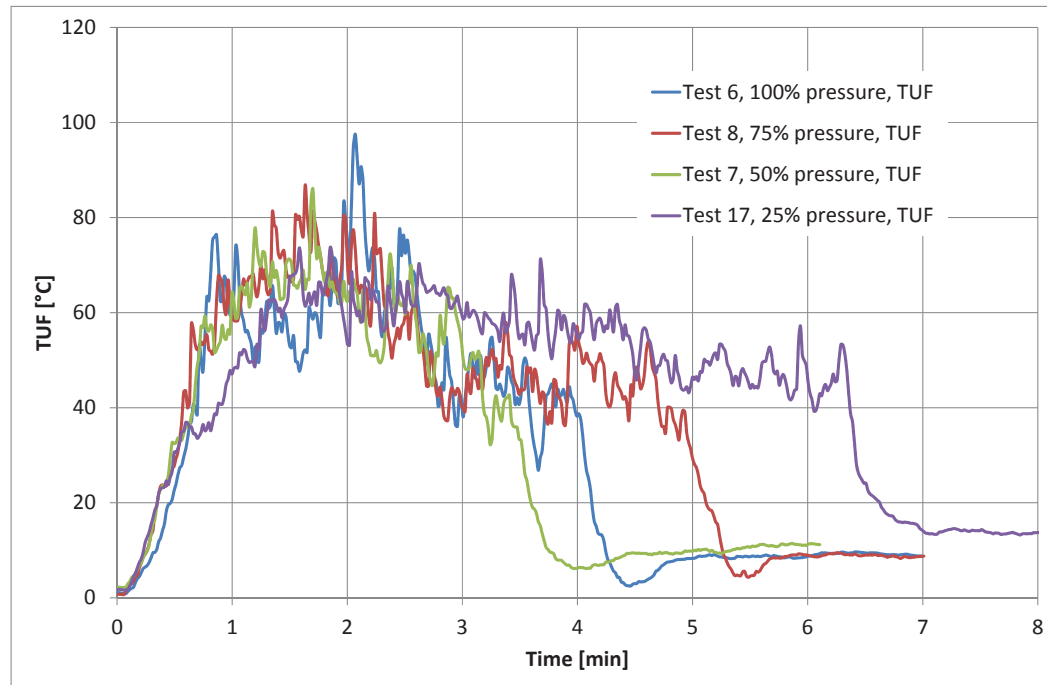
Figure 11 – Temperature Uniformity Factors versus time for 100% obstructed fire tests.

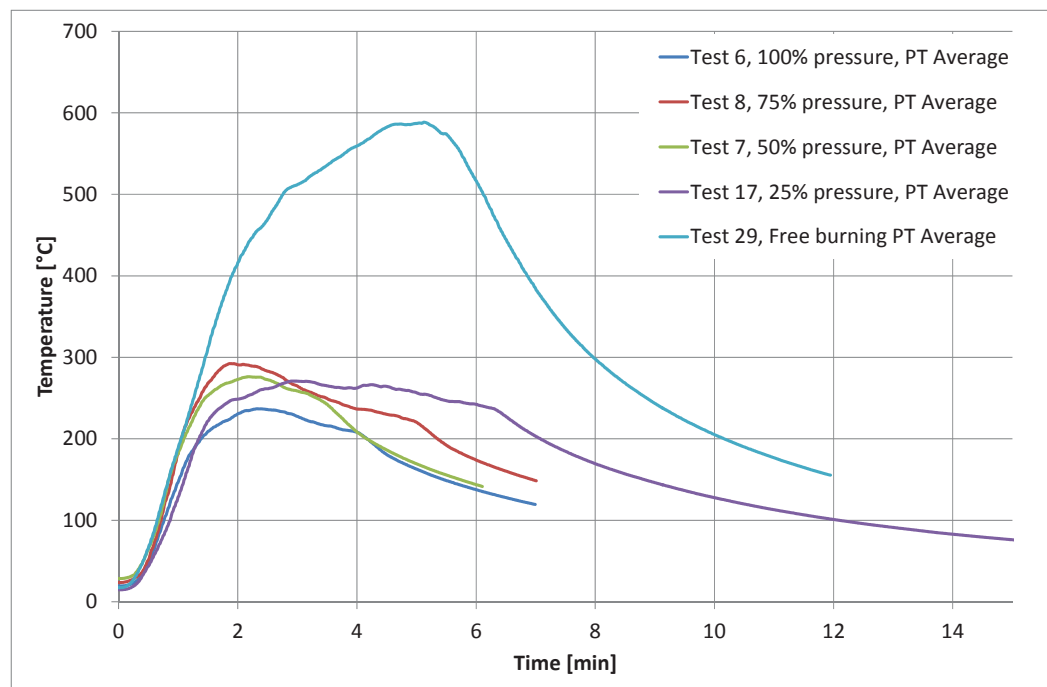
Figure 12 - Average PT (plate thermometer) temperatures versus time for 100% obstructed fire tests.

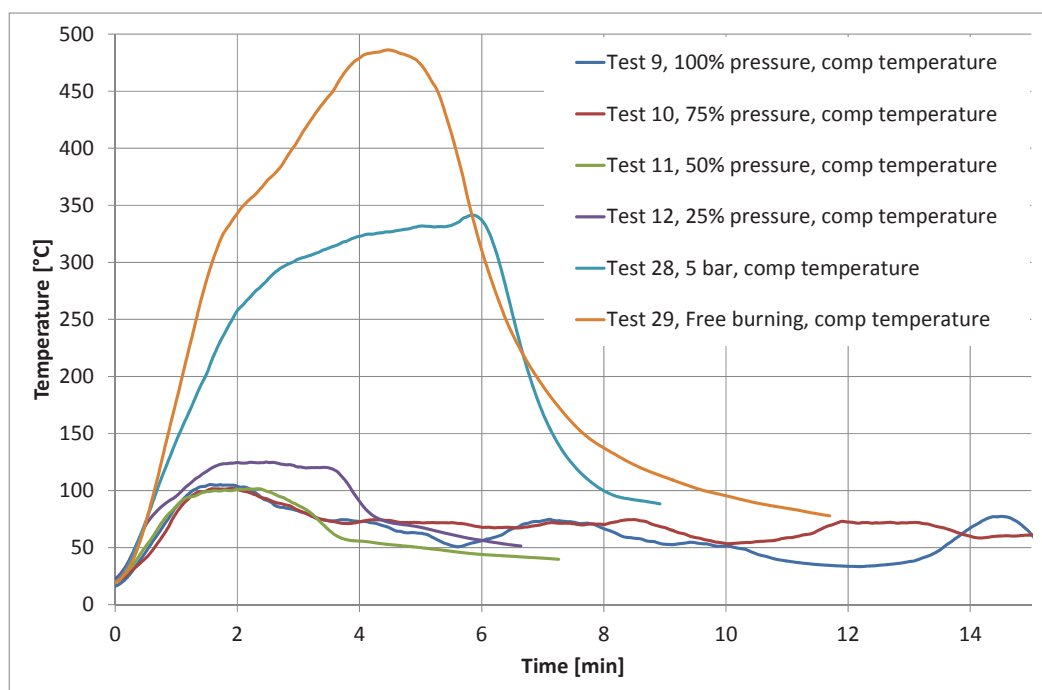
Figure 13 – Average compartment temperatures versus time for 50% obstructed fire tests.

Observations for 50% obstructed fire tests (Tests 9-12, 28)	
Gas temperatures	<p>For Tests 9-12 (100%, 75%, 50% and 25 % of design pressure respectively) the water mist system cooled the compartment efficiently. As was observed for the unobstructed fire tests, there was a correlation between applied pressure and system efficiency in cooling the space. Test 28 (at 5 bar) continued until all the fuel was consumed.</p> <p>If the gas temperatures in Test 28 (5 bar pressure) are compared to those for Test 29 (free burning), it can be seen that a small amount of water in the fire compartment is sufficient to significantly reduce the average compartment temperature (from 490 °C to 340 °C). Since the radiation to the floor is proportional to the gas temperature [K] to the power of 4, the emitted radiation from the gas volume in Test 28 is reduced to less than 50% that in Test 29. Since a flashover typically occurs when the compartment temperature is between 500 – 600 °C and the radiation level to the floor is 15 – 20 kW/m<sup>2</sup> [2] it is obvious that, even at fire main pressure (5-10 bar) the high pressure water mist system can significantly reduce the probability of flashover. This, in combination with the fact that lower compartment temperatures delay failures of surrounding divisions, will significantly improve the probability of a fire being contained in the original compartment even if a door etc. is left open.</p>

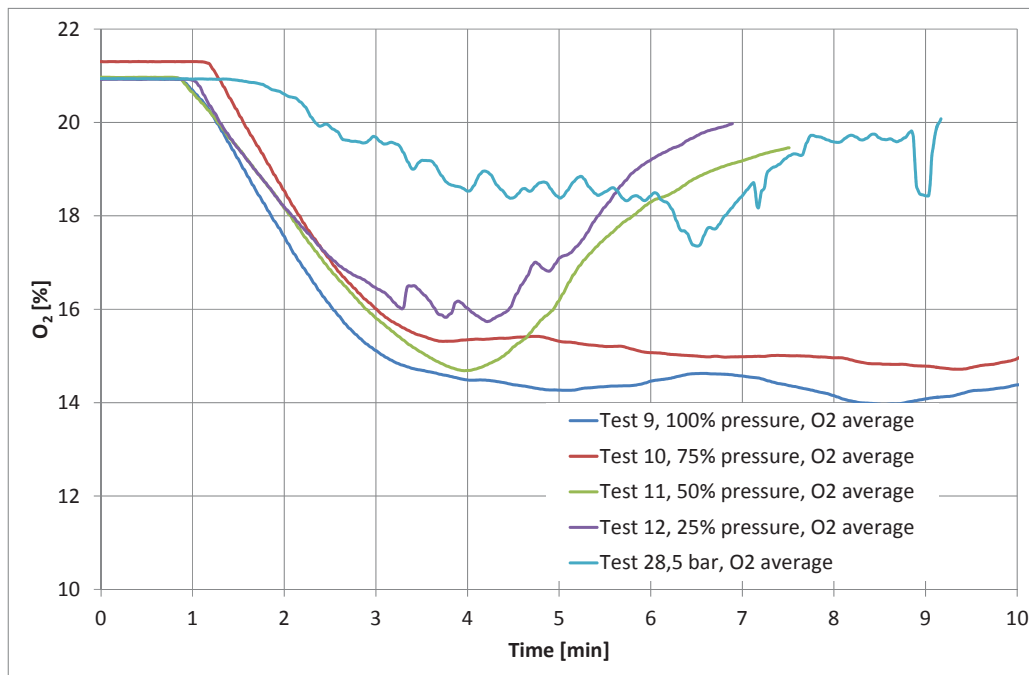
Figure 14 — Average oxygen concentrations versus time for 50% obstructed fire tests.

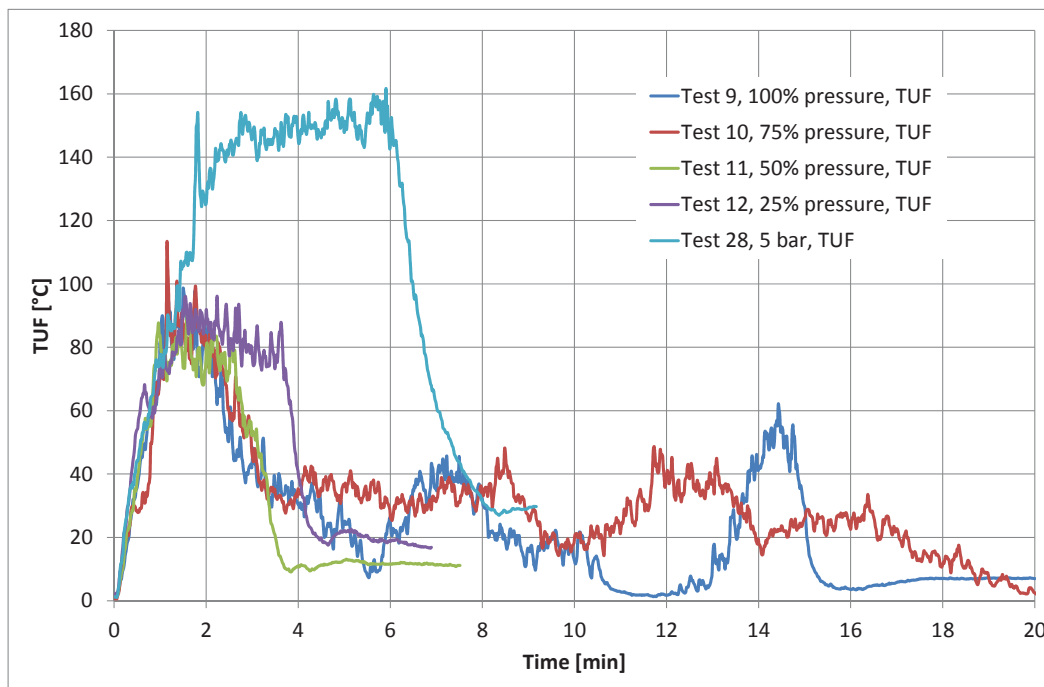
Figure 15 – Temperature Uniformity Factors versus time for 50% obstructed fire tests.

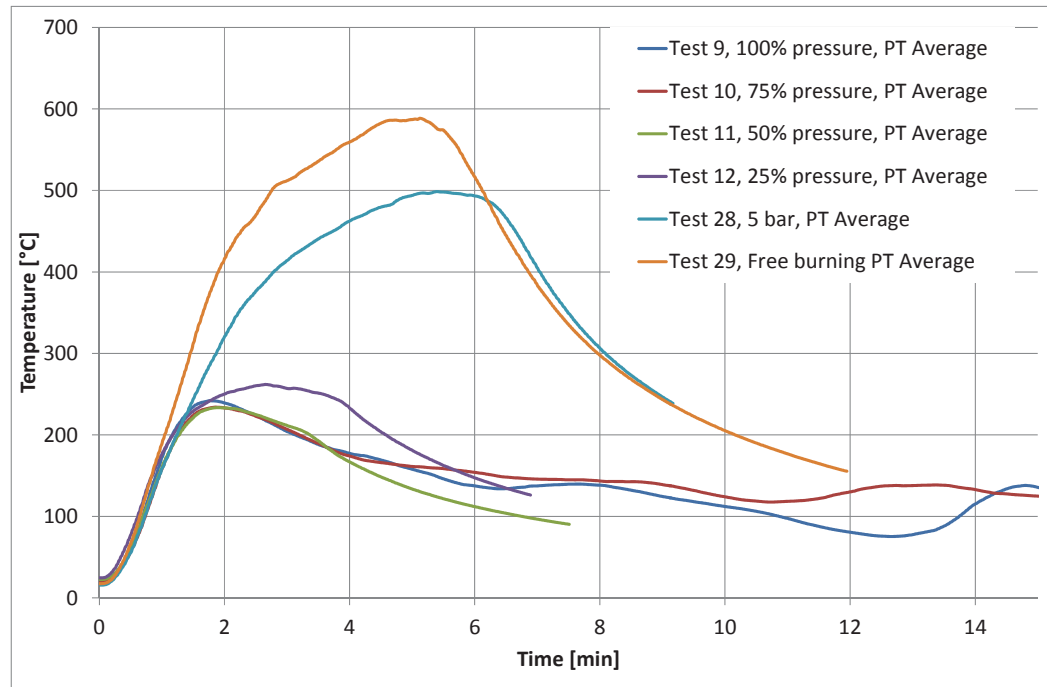
Figure 16 - Average PT (plate thermometer) temperatures versus time for 50% obstructed fire tests.

PT temperatures	<p>For Tests 9 - 11 , the maximum average PT-temperature was about the same (all between 234 and 242°C). In Test 12 the maximum average PT-temperature was 262°C. In Test 28, the average PT temperature increased until the fuel was consumed. It peaked at about 500 °C.</p>
Extinguishment	<p>In Tests 9 and 10 the fire was not extinguished before the fuel was consumed. In Tests 11 and 12 the fire was extinguished quite rapidly (2:50 min and 3:20 min after activation). In Test 28 the fire was not extinguished until the fuel was consumed. As was observed for the unobstructed Tests 1 and 2, in Tests 9 and 10 the fire was probably not extinguished because the water mist system cooled the compartment to efficiently. This is discussed further in the Discussions section.</p>
TUF	<p>In Tests 9 and 10 the TUF value peaked at about 80-90 °C when the average temperature in the compartment was about 100 °C and was reduced to about 30°C three and a half minute after activation when the average temperature in the compartment was about 60 °C. It stayed at this level until the fuel was consumed. In Tests 11 and 12 the TUF value also peaked at about 80-90 °C and decreased slowly until the fire was extinguished. In Test 28 the TUF value increased until the fuel was consumed and peaked at about 160 °C. This indicates that the gases in the compartment were not very well-mixed in any of the tests.</p>

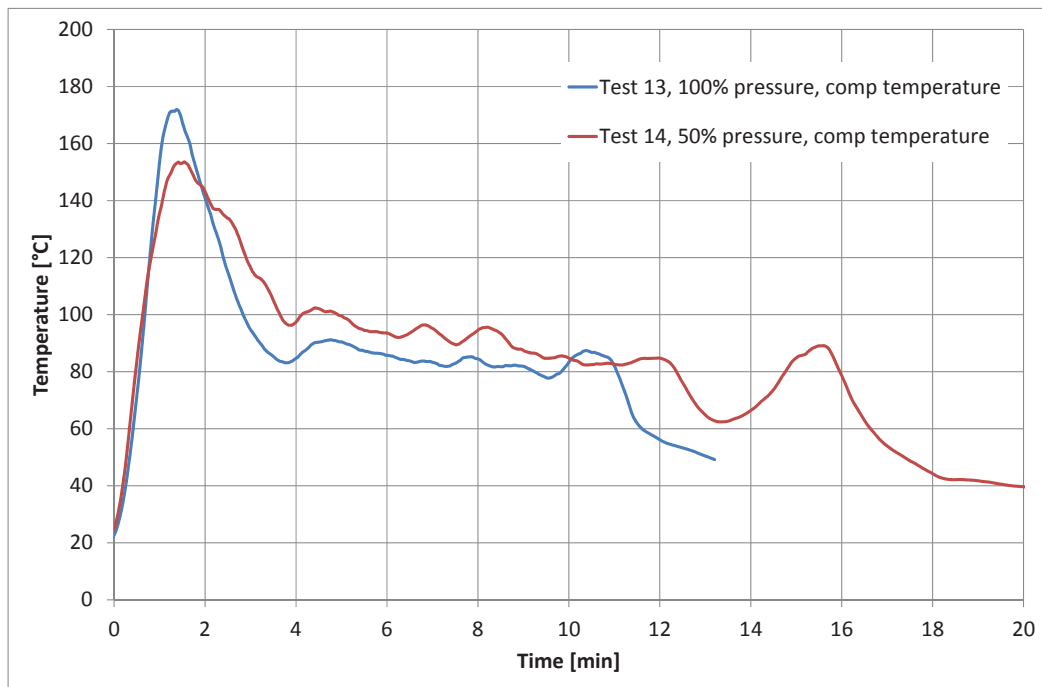
Figure 17 - Average compartment temperatures versus time for tests with 2 nozzles.

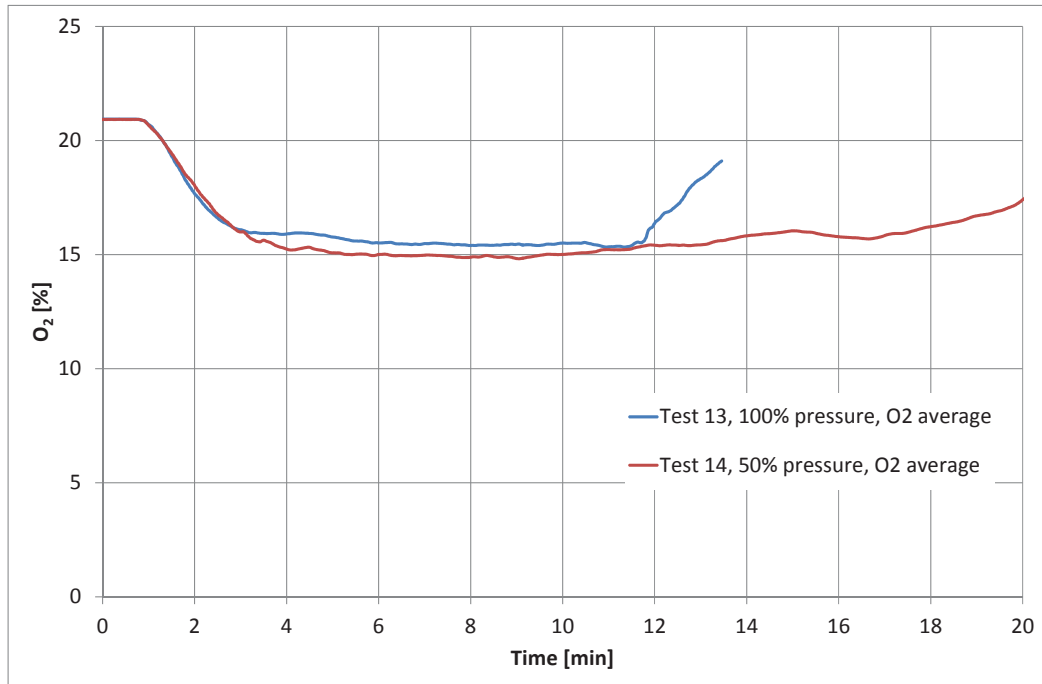
Figure 18 - Average oxygen concentrations versus time for tests with 2 nozzles.

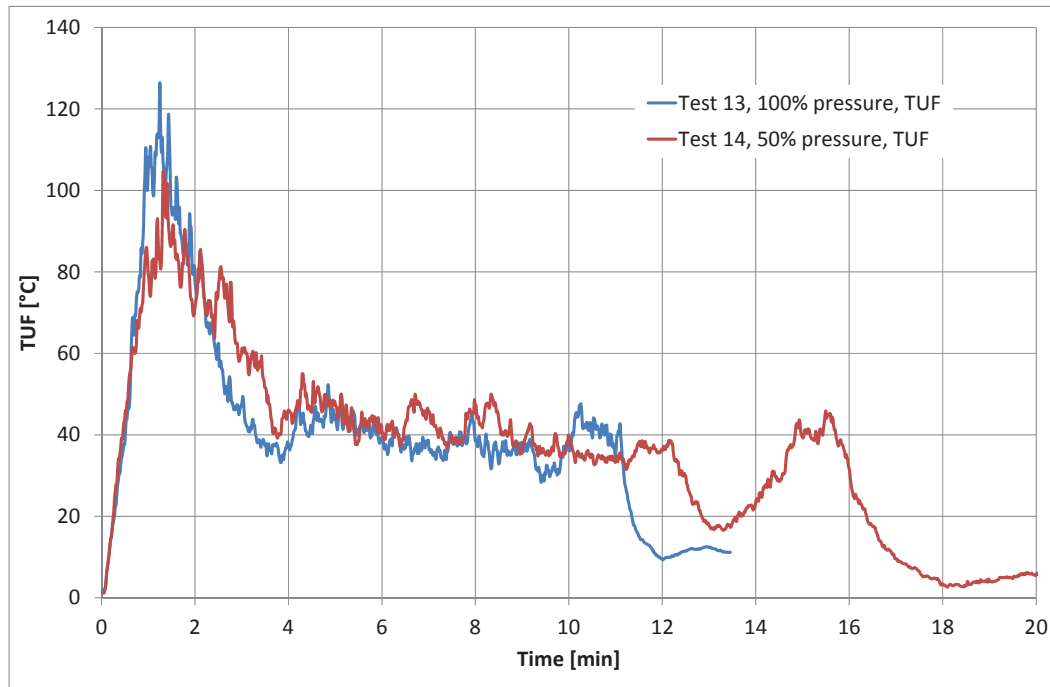
Figure 19 - Temperature Uniformity Factors versus time for tests with 2 nozzles.

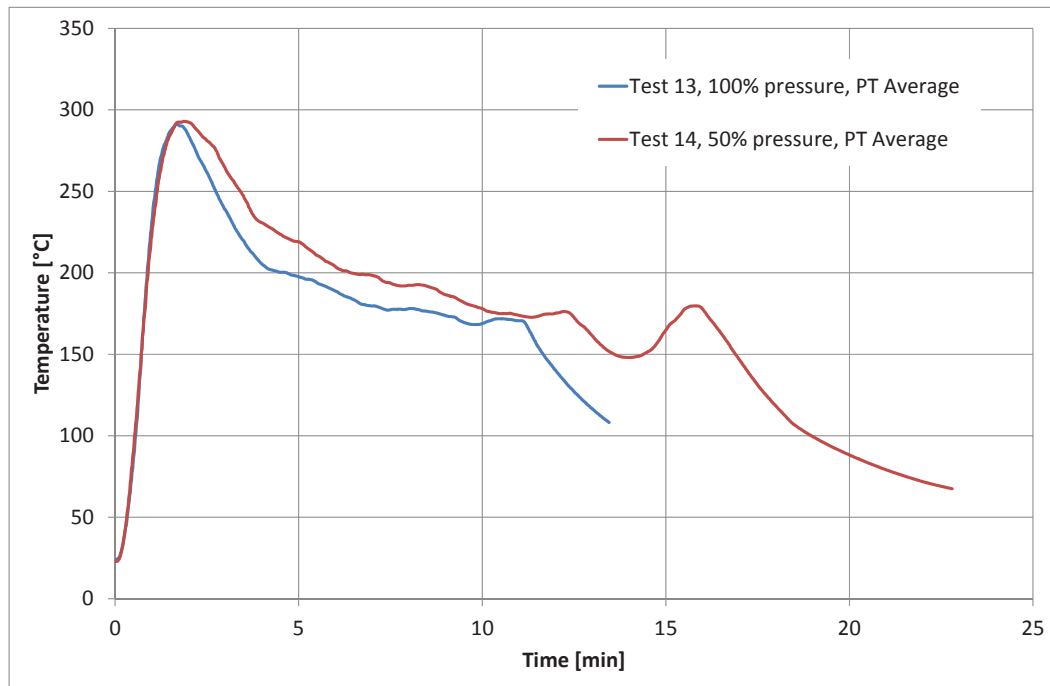
Figure 20 - Average PT (plate thermometer) temperatures versus time for tests with 2 nozzles.

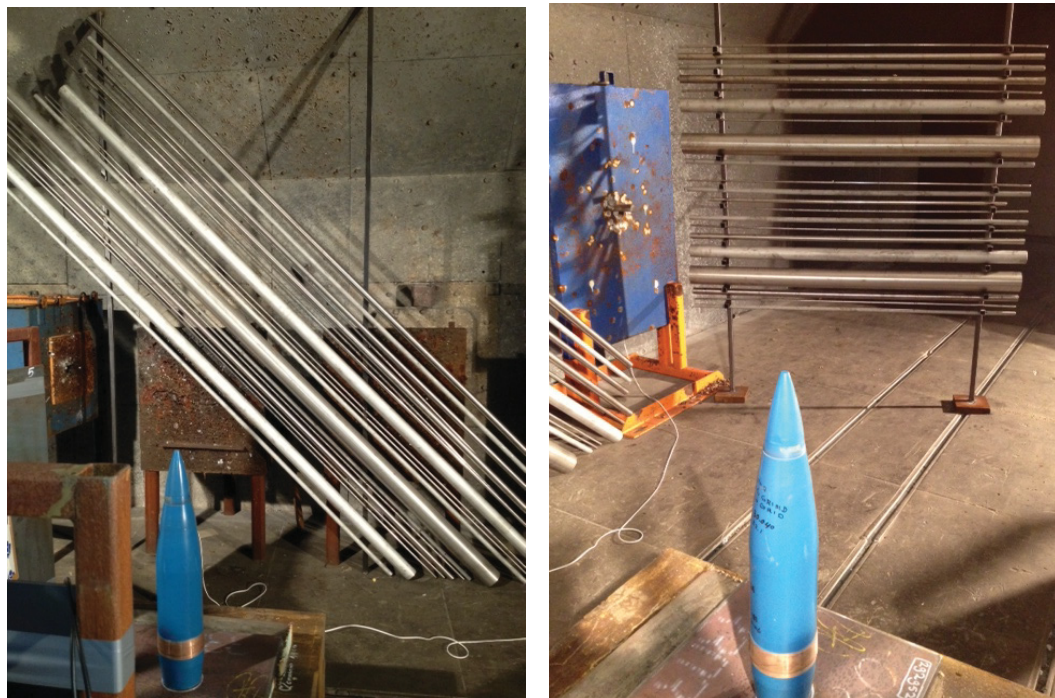
**Figure 21 – Photo of setup prior to grenade test to damage piping segments.**

Before this series of tests, pipes of relevant dimensions and qualities for use in a high pressure water mist system were installed in a blast chamber at TNO and a grenade was detonated. Two racks of pipes (see Figure 21) were placed 2 meters and 3 meters away from the grenade. The caliber and type of grenade cannot be revealed because of classification. The grenade in the photographs is a dummy and is not the grenade that was used in the trials. This resulted in damage to the pipes; some of the pipes were severed while others suffered punctures of various sizes. A number of damaged pipe sections were selected for use in the fire testing described in this section. The damage scenarios are documented in Appendix 1.

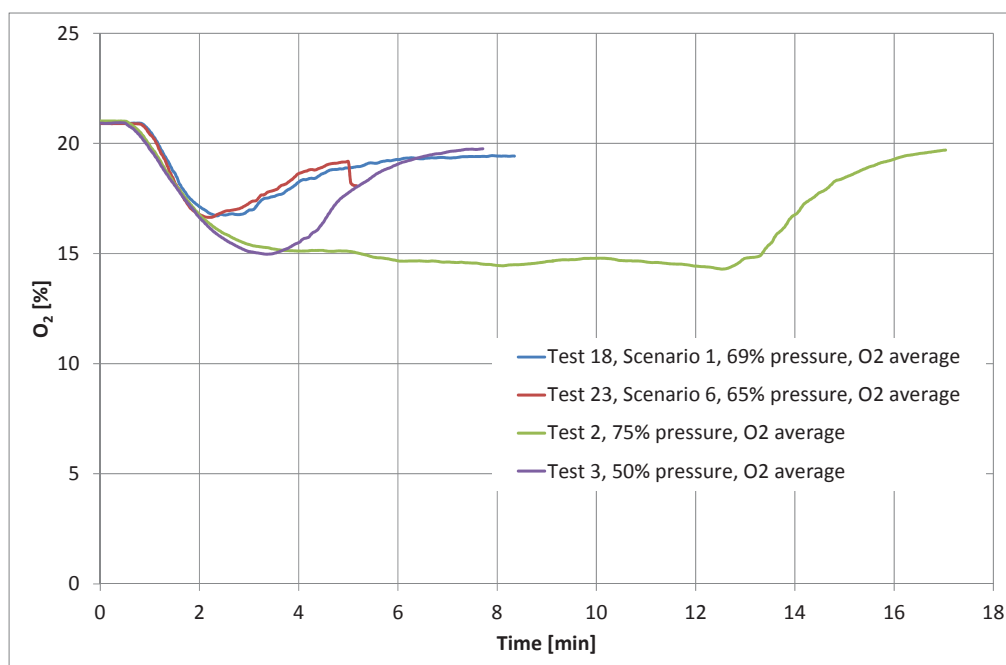
**Figure 22 - Figure 23 - Average oxygen concentrations versus time for tests with damaged pipes and pressures between 50% and 75% of normal operating pressure. Damage scenarios (Tests 18 and 23) are compared with intact system with reduced pressure (Tests 2 and 3).**

Observations for damage scenario tests with 50% - 75% of normal operation pressure	
Gas temperatures	The damaged water mist system reduced the compartment temperatures faster than was observed for the tests with intact piping and comparable system pressure. This is most likely due to the increased water discharged density in the compartment.
PT temperatures	In Test 23 the maximum average PT temperature was about the same as in Tests 2 and 3 (264°C). In Test 18 the maximum PT-temperature is slightly lower (240°C). The temperature was reduced faster in the tests with damaged piping.
Extinguishment	In both Tests 18 and 23 the fire was extinguished rapidly, in Test 18 1:30 min after activation and in Test 23 1:25 min after activation of the water mist system.
TUF	In Tests 18 and 23 the TUF value peaked at about 130 °C – 140 °C when the average temperature in the compartment was about 110 °C – 130 °C. In both tests the TUF value was rapidly reduced following activation of the water mist system, more rapidly than observed in Tests 2 and 3. This indicated that the gases in the compartment were quite well-mixed in these two damage scenarios (Tests 18 and 23).

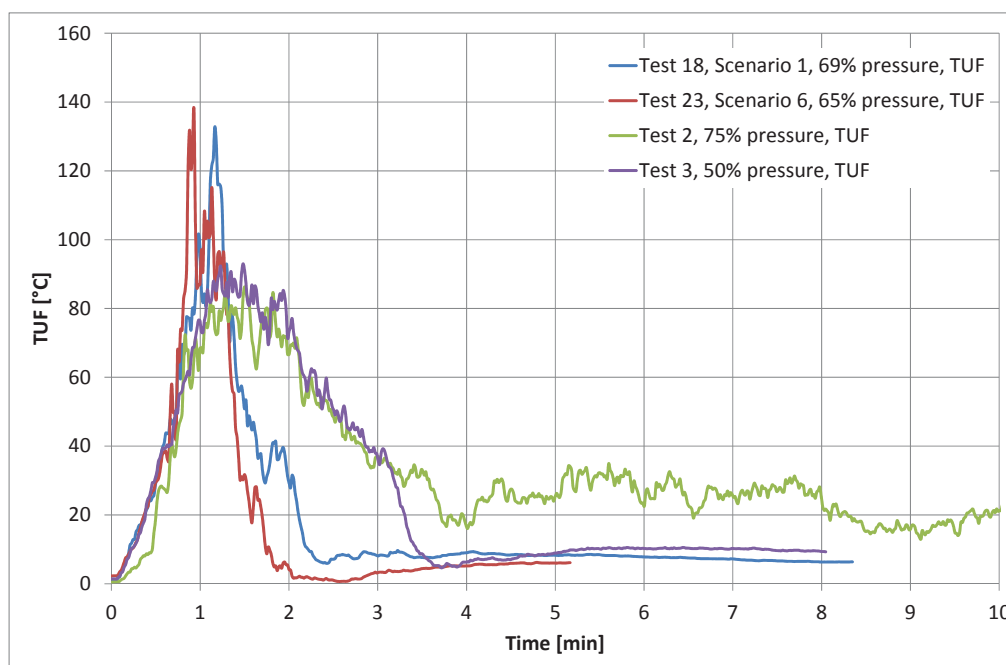
**Figure 24 - Temperature Uniformity Factors versus time for tests with damaged pipes and pressures between 50% and 75% of normal operating pressure. Damage scenarios (Tests 18 and 23) are compared with intact system with reduced pressure (Tests 2 and 3).**

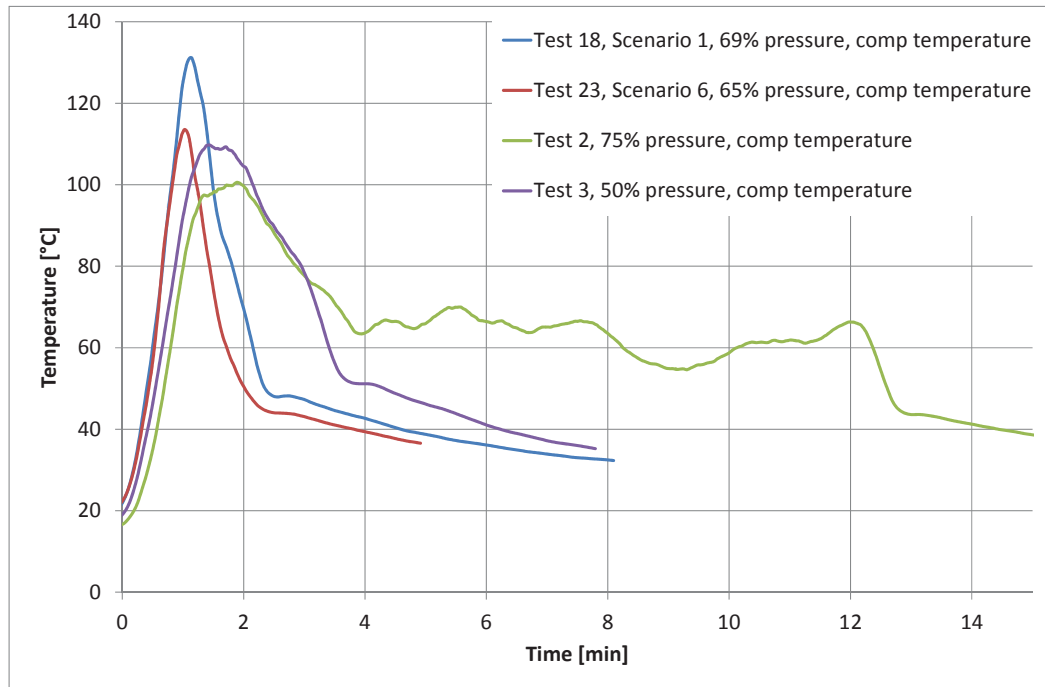
**Figure 25 - Average compartment temperatures versus time for tests with damaged pipes and pressures between 50% and 75% of normal operating pressure. Damage scenarios (Tests 18 and 23) are compared with intact system with reduced pressure (Tests 2 and 3).**

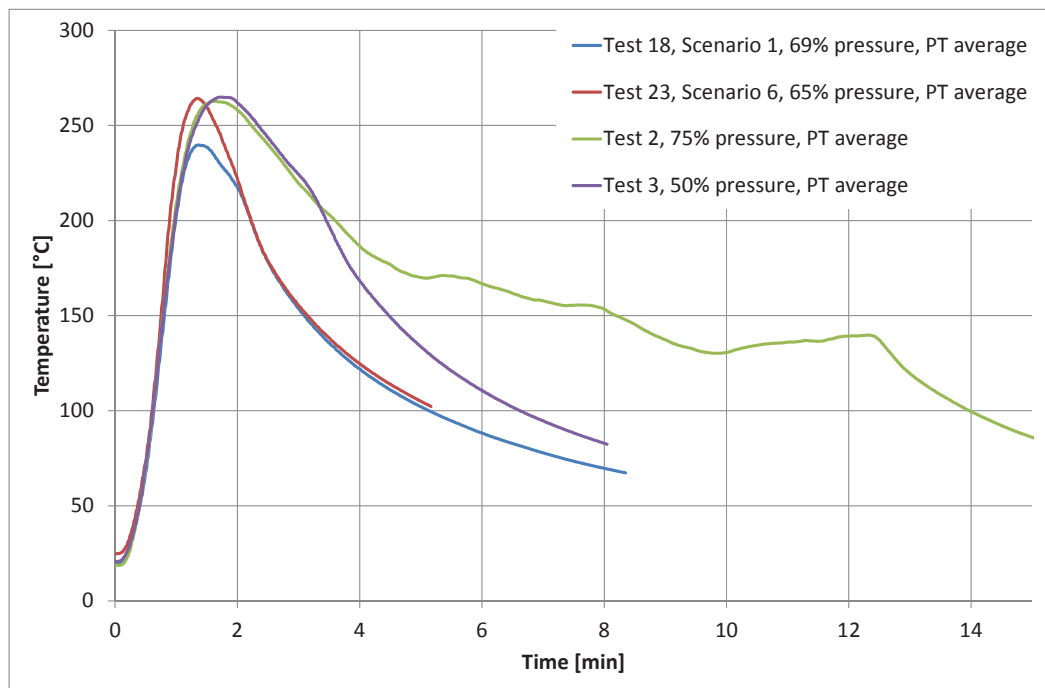
**Figure 26 - Average PT (plate thermometer) temperatures versus time for tests with damaged pipes and pressures between 50% and 75% of normal operating pressure. Damage scenarios (Tests 18 and 23) are compared with intact system with reduced pressure (Test 2 and 3).**

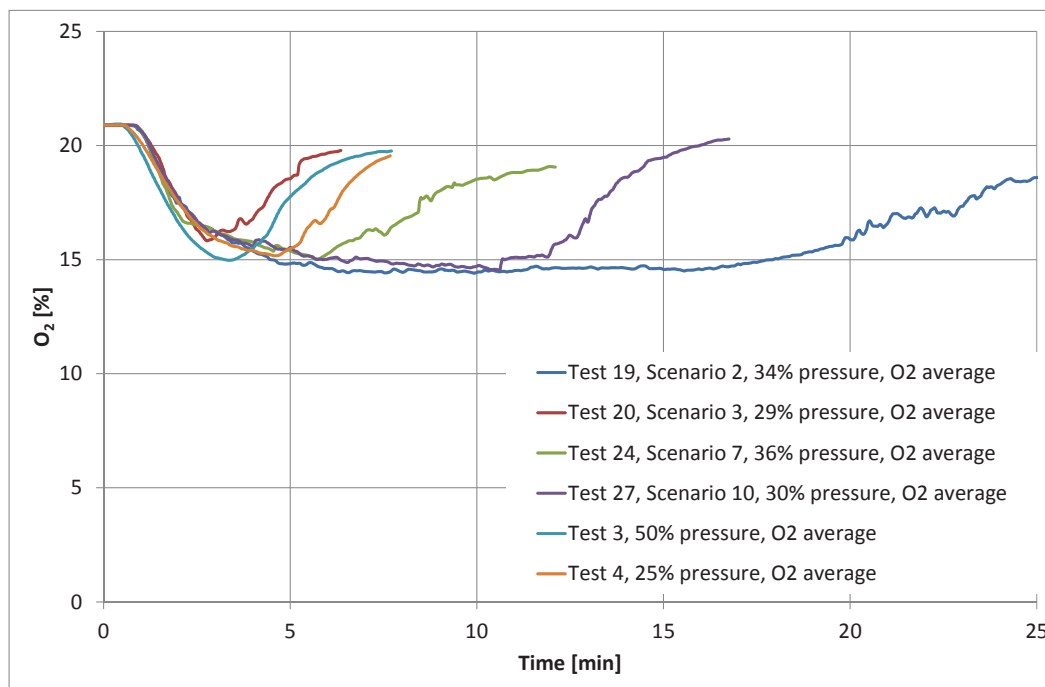
Figure 27 - Average oxygen concentrations versus time for tests with damaged pipes and pressures between 25% and 50% of normal operating pressure. Damage scenarios (Tests 19, 20, 24 and 27) are compared with intact system with reduced pressure (Tests 3 and 4).

Observations for damage scenario tests with 25% - 50% of normal operation pressure	
Gas temperatures	The water mist system with damaged piping reduced the compartment temperatures faster the system with intact piping and comparable system pressure. The initial peak temperature was higher in the tests with the damaged water mist system.
PT temperatures	The maximum average PT-temperature varied between 244°C and 283°C. No obvious difference between the performance of damaged systems and intact systems with comparable pressures was observed.
Extinguishment	Even though the system pressure in these damage scenarios only varied between 29 and 36 % of normal operating pressure, the time to extinguishment varied considerably. In Test 19 the fire was not extinguished before the fuel was consumed. In Test 20 the fire was extinguished 2:00 min after activation, in Test 24 4:50 min after activation and in Test 27 10:59 min after activation of the water mist system.
